Water Compliance Inspection Report

**National Pollutant Discharge Elimination System (NPDES)
Concentrated Animal Feeding Operation (CAFO) Inspection
Non-Sampling**

**Sage Dairy
5888 Sandy Avenue
Emmett, Idaho 83617**

**Inspection date: April 17, 2013
Report completion date: May 3, 2013**

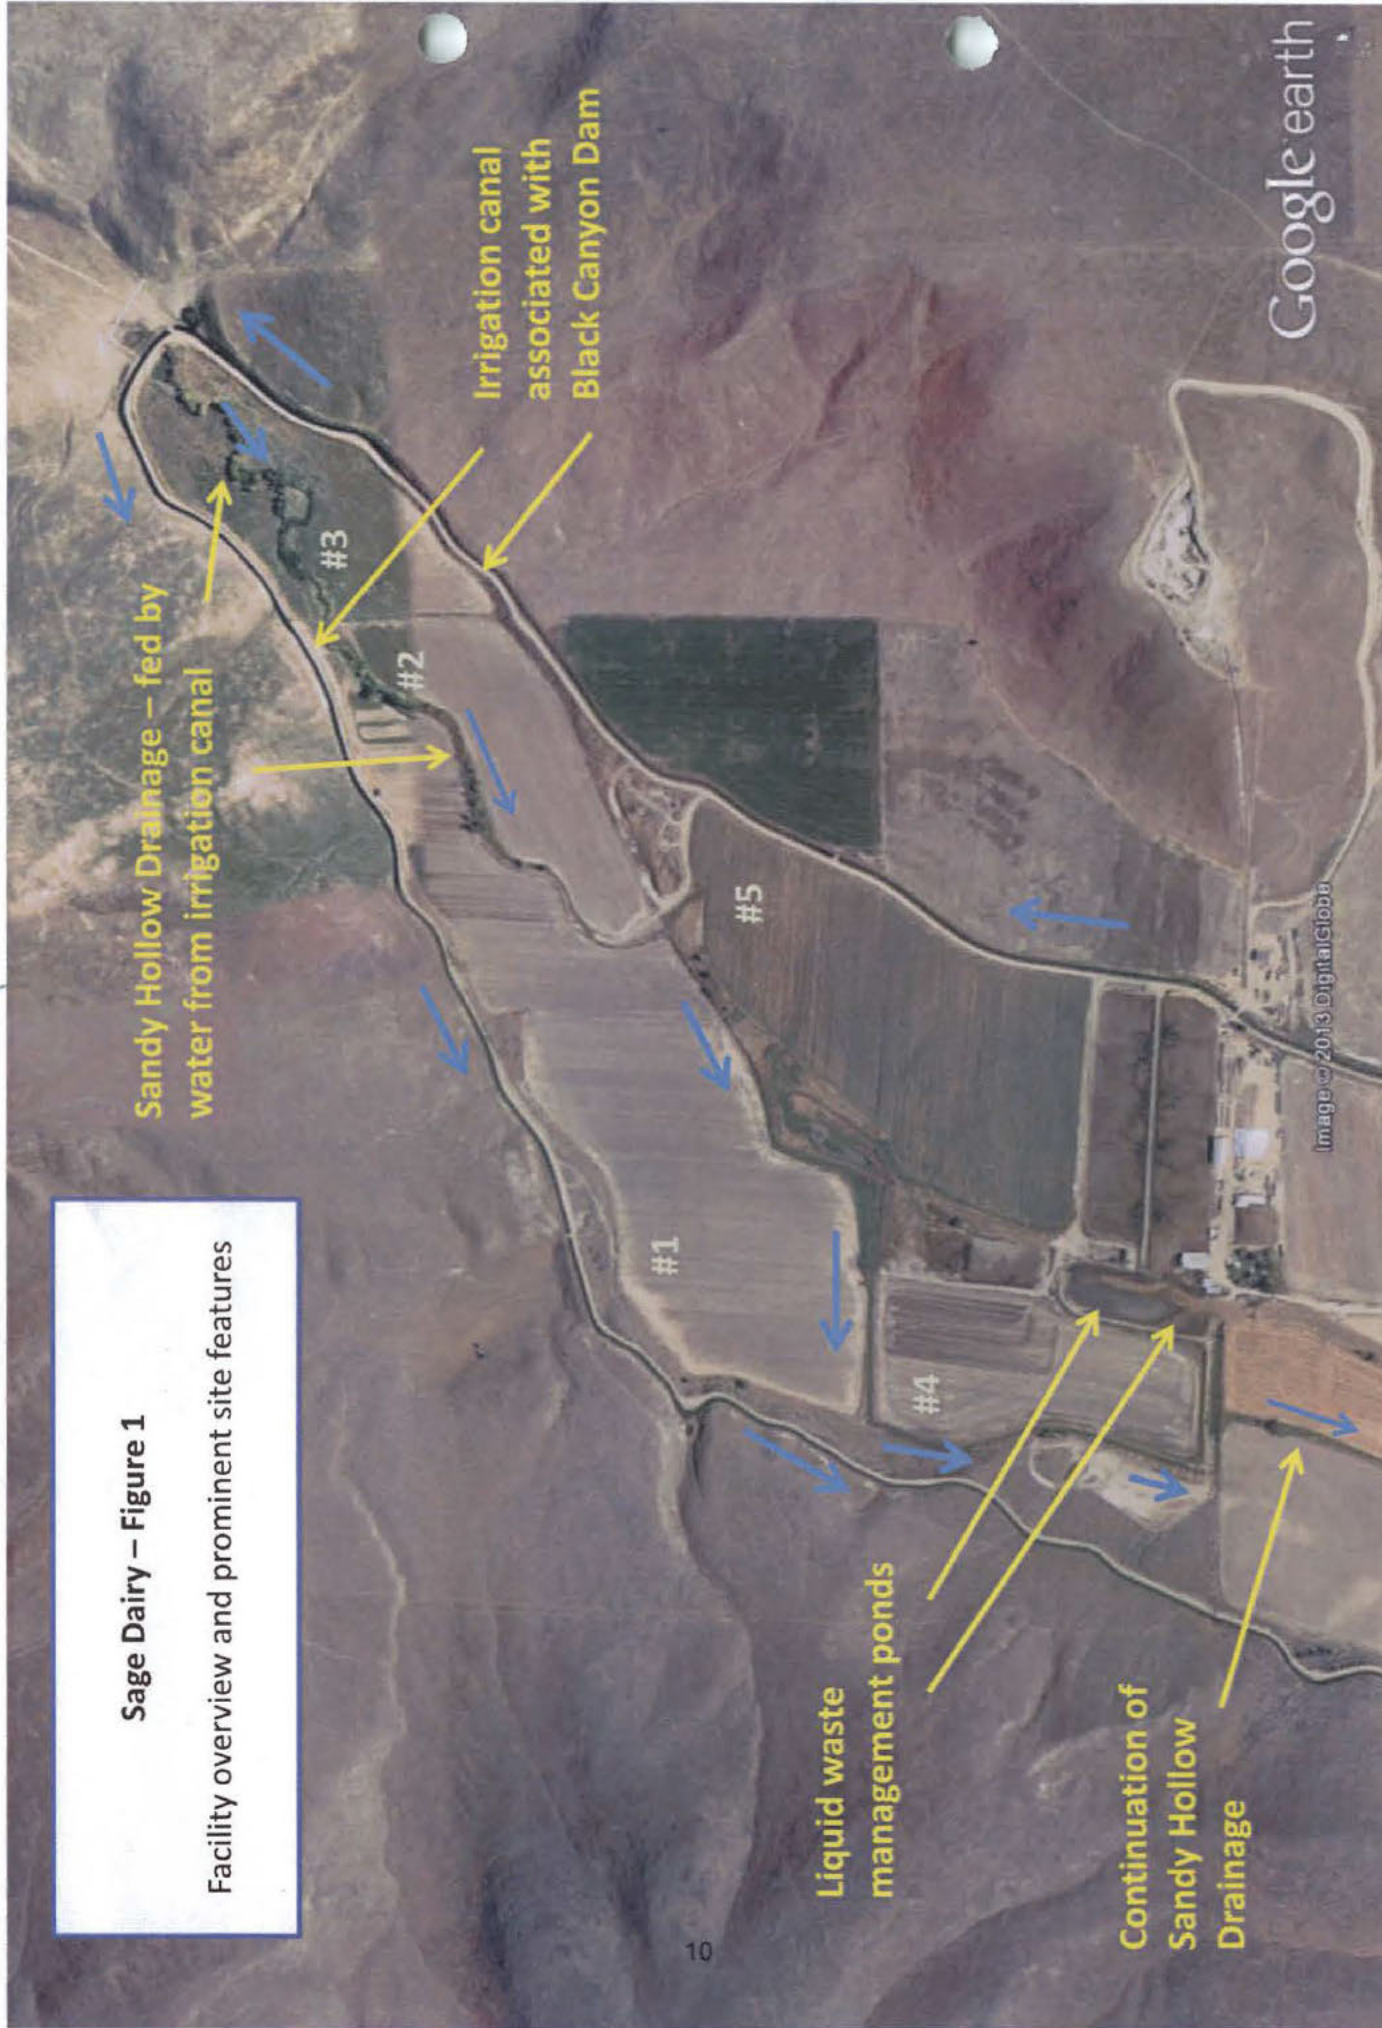
Sage Dairy – Figure 1

Facility overview and prominent site features

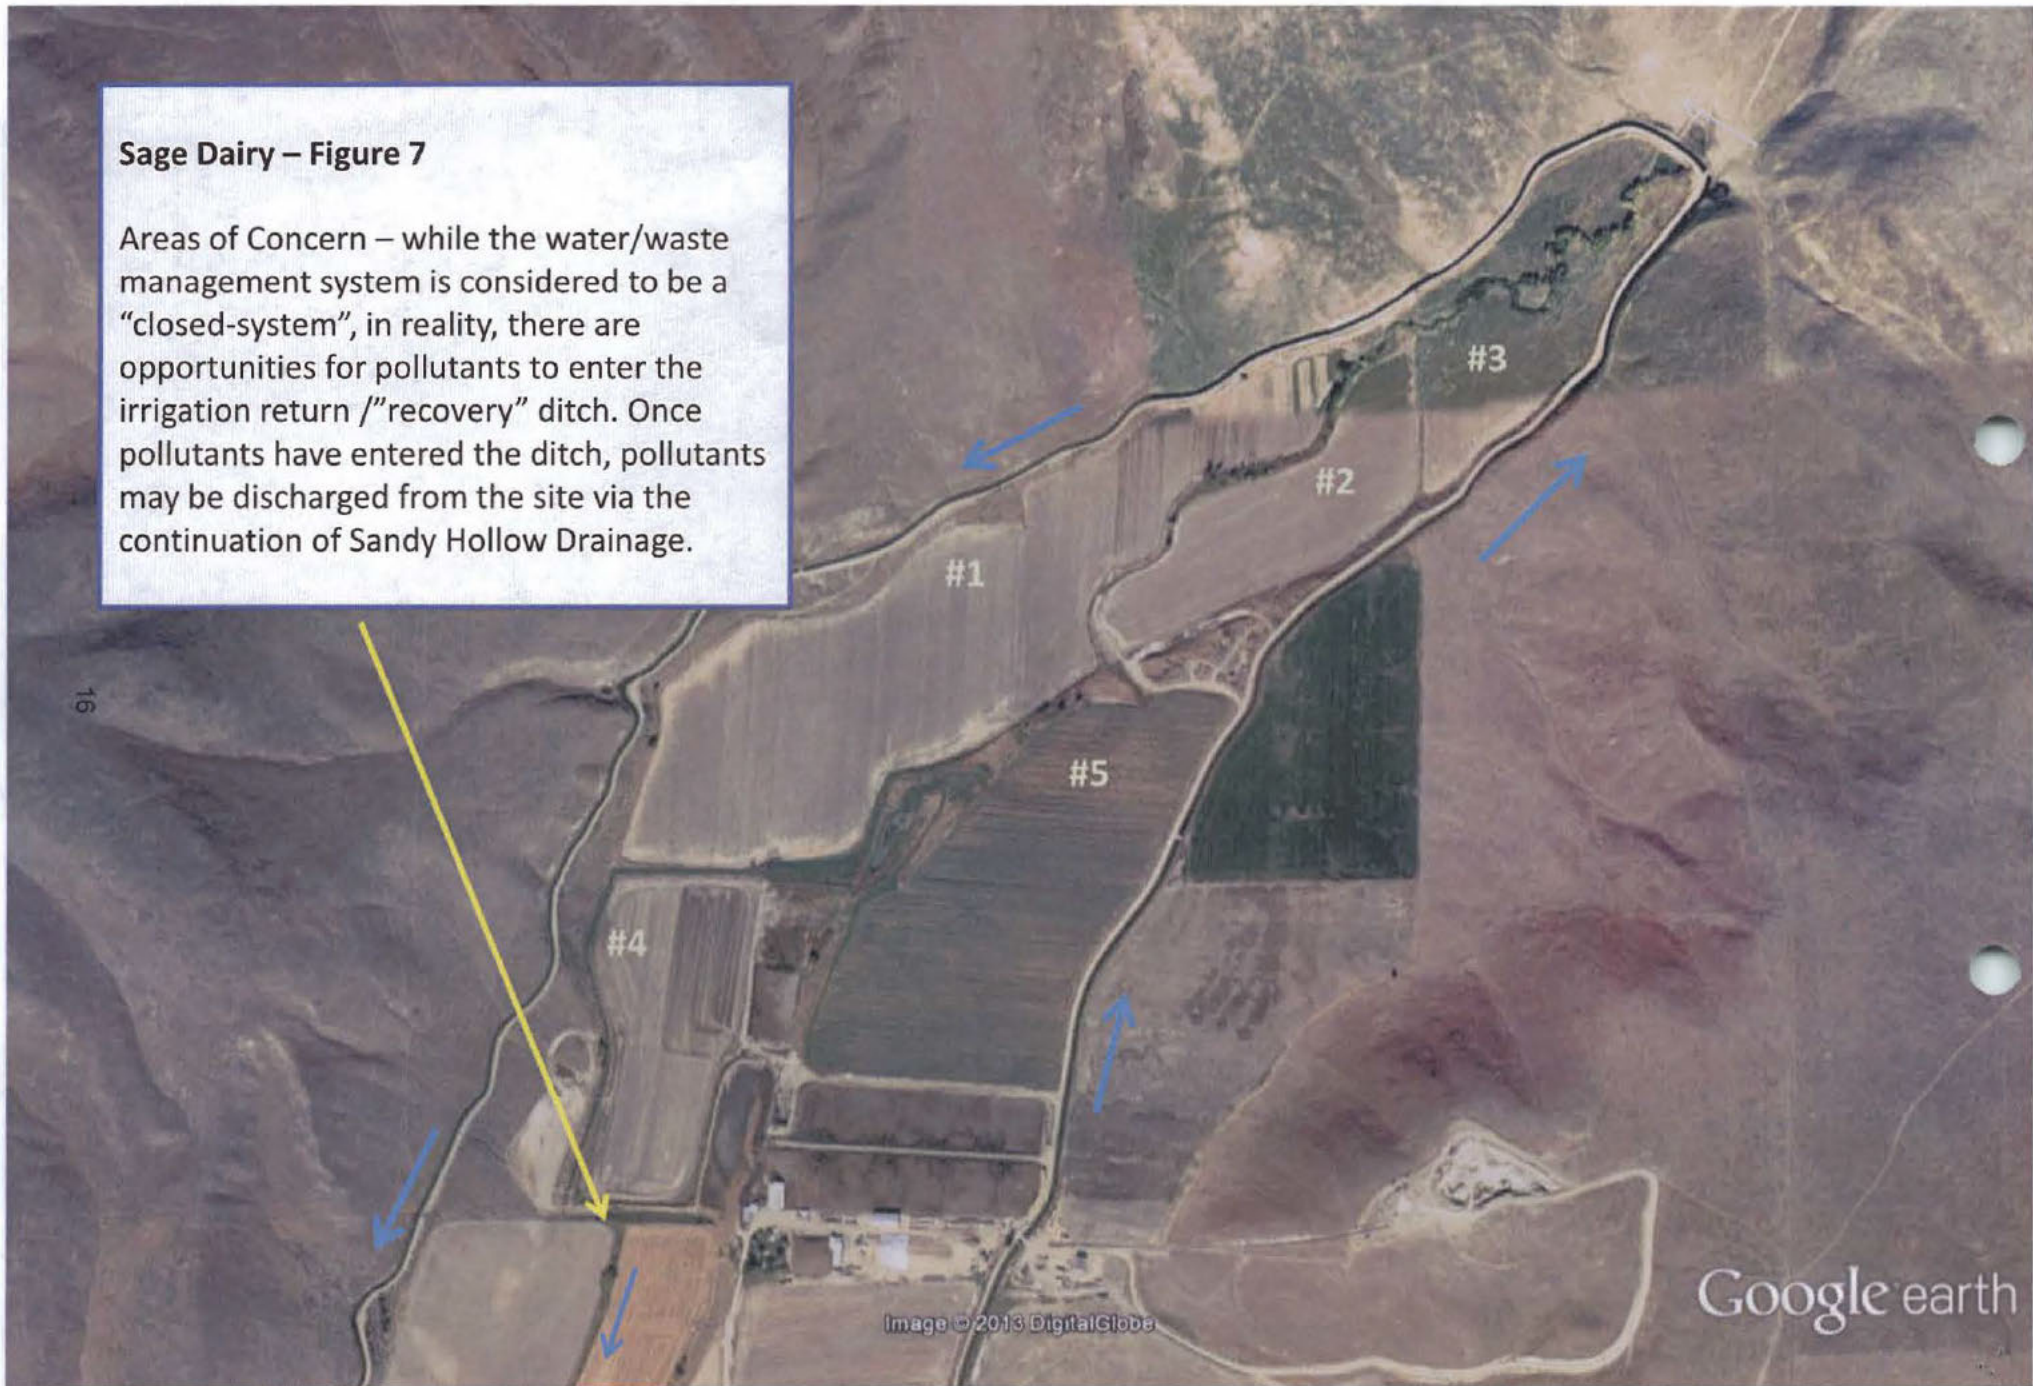
Sage Dairy – Figure 7

the west end of the irrigation ditch (see Photos 4-5) to insure that the system is indeed "closed". Absent this hydraulic head, irrigation return water from field #4 could flow back toward the west and enter the WOUS via a perpendicular lateral (a continuation of Sandy Hollow Drainage) that flows south from the irrigation return ditch (located about a third of the way from the ditch's western end) toward the Payette River (see Figure 7 and Photo 5).

As noted previously in the *Waste Management* section of this report, the "closed-loop" system that utilizes liquid waste from the dairy operations for surface irrigation is not completely closed – the potential for a discharge of pollutants (processed wastewater from the dairy operations) to the WOUS does exist given the system's current design.

Areas of Concern – while the water/waste management system is considered to be a “closed-system”, in reality, there are opportunities for pollutants to enter the irrigation return / “recovery” ditch. Once pollutants have entered the ditch, pollutants may be discharged from the site via the continuation of Sandy Hollow Drainage.

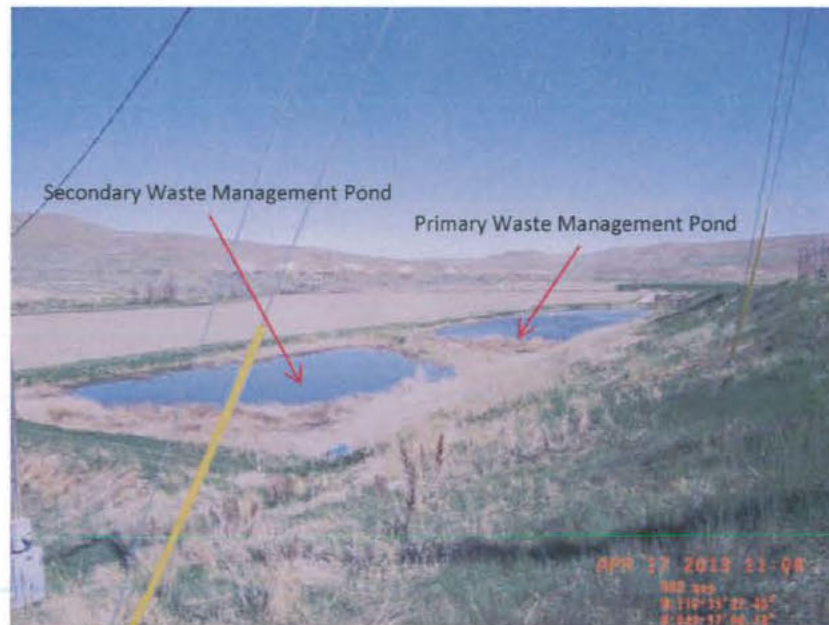
Photo No. 1

Photo shows the waste management ponds at the Sage Dairy (Facility). Liquids and solids from the Facility initially go to the primary waste management pond where solids settle out. The liquids pass through a "weeping wall" into the secondary separation pond (Refer to Figure 2).

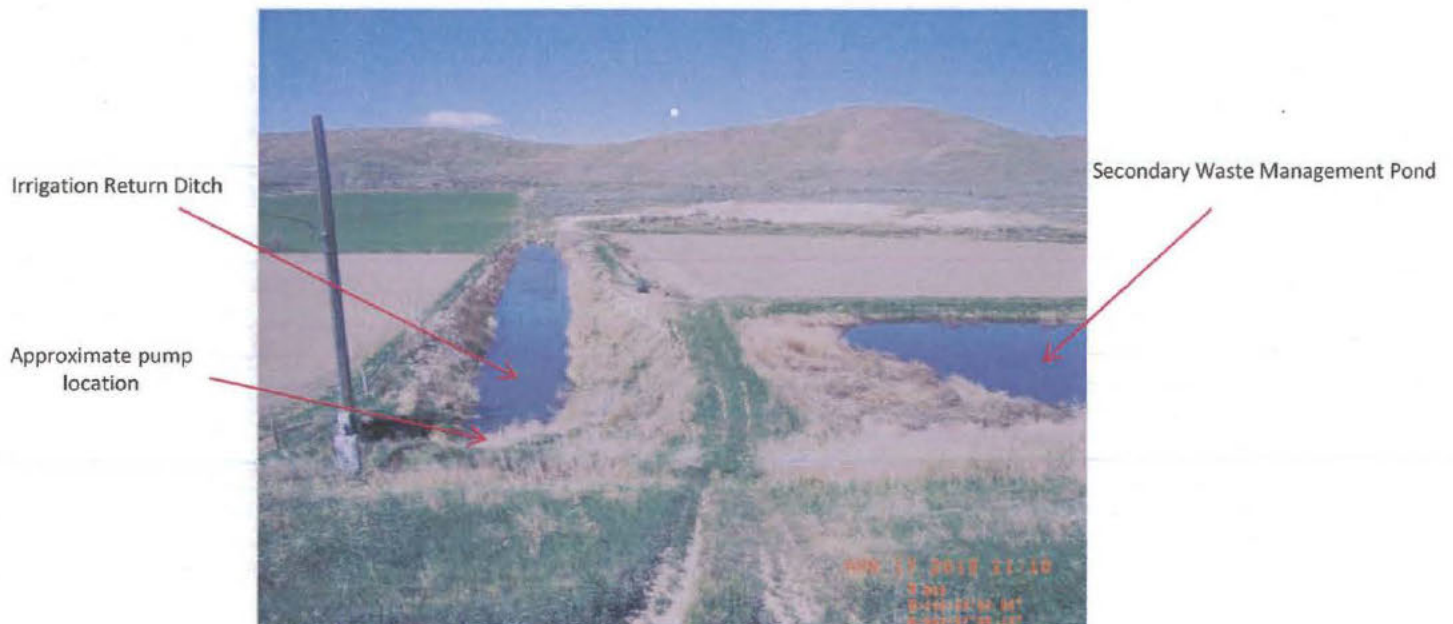
Photo No. 2

Photo shows the secondary separation pond and the irrigation return ditch (left side of the photo). The waste management ponds and the irrigation return/recovery ditch are also depicted in Sage Dairy – Figure 2. Nearby fields are irrigated using a mixture of these two water sources. According to the on-site representative, Mr. Terry Jones, Land Owner, 9% of the water used to irrigate the nearby fields is from the liquid in the secondary waste management pond and 91% is from the irrigation return ditch.

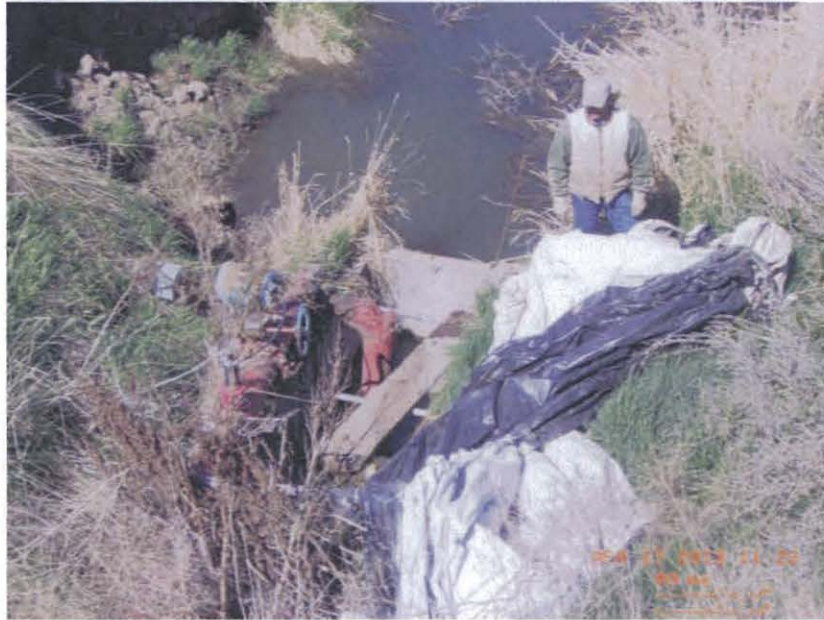
Photo No. 3

Photo shows the pumping system, consisting of a pump, piping, check valves, and a butterfly control valve, which draws water from the irrigation return ditch (91%) and the separation pond (9%) shown in Photo Nos. 1 and 2 above.

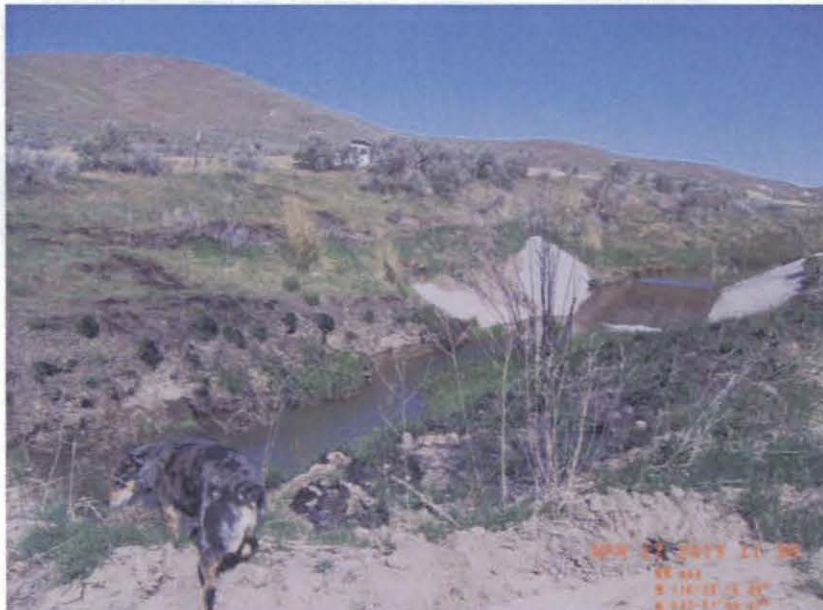
Photo No. 4

Photo shows the Sandy Hollow Drainage near/above the location where it flows into the irrigation return ditch.

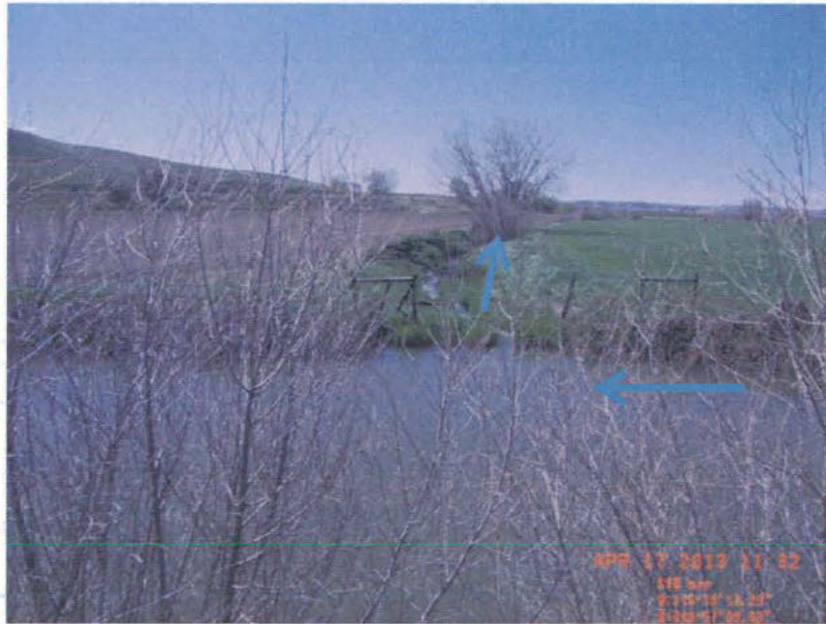
Photo No. 5

In the forefront of the photo is the irrigation return ditch. The irrigation return ditch feeds into a perpendicular lateral which is a continuation of the Sandy Hollow Drainage that eventually flows to the Payette River. This is an area of concern because irrigation return water from Field No. 4 could potentially flow into the irrigation return ditch and discharge to this perpendicular lateral (Refer to Figure 7).

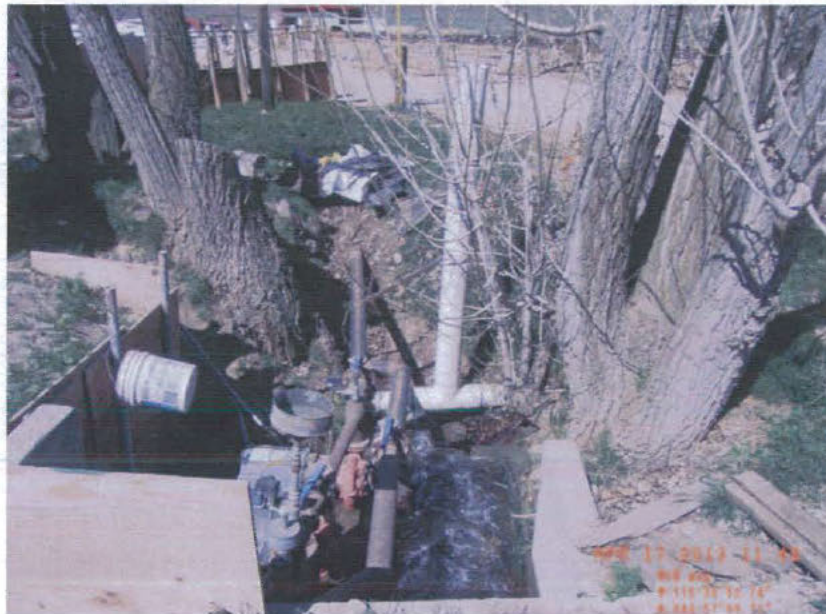
Photo No. 6

The 91% irrigation ditch/9% separation pond mixture mentioned in Photo No. 2 above is pumped uphill and flows into this gated irrigation pipe.

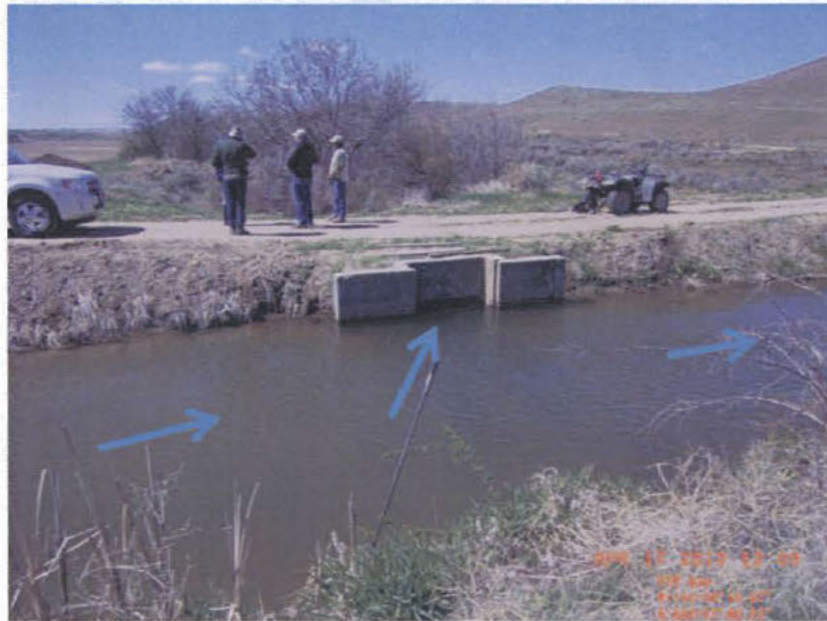
Photo No.7

Photo taken overlooking the irrigation canal (refer to Figure 1). When water in the canal reaches a certain level, overflow passes through concrete conveyance and into the Sandy Hollow Drainage.

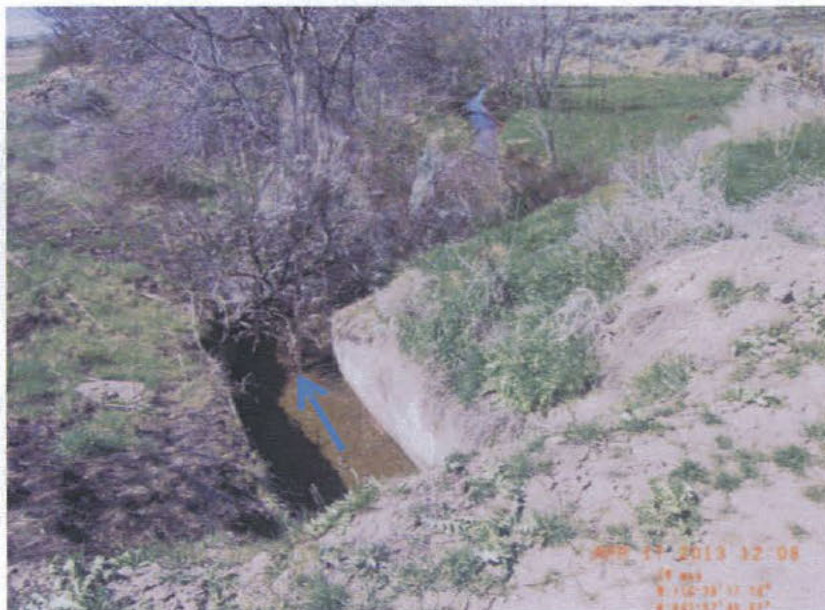
Photo No. 8

Photo shows the Sandy Hollow Drainage mentioned in Photo No. 7 above. The Sandy Hollow Drainage flows through the Facility. Irrigation return water from land application to the surrounding fields would flow into the Sandy Hollow Drainage and a portion would flow into the perpendicular lateral shown in Photo No. 5

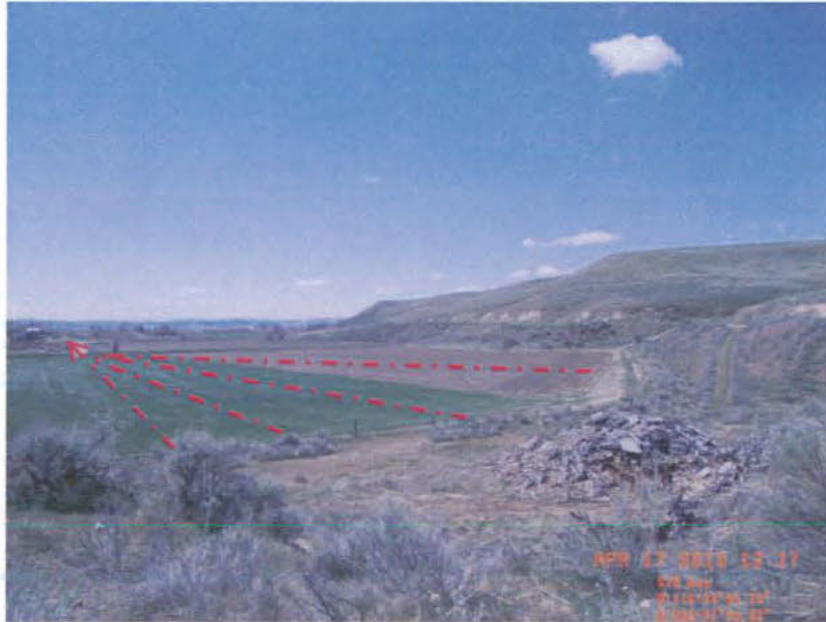
Photo No. 9

There is also a potential for a dry-weather discharge from fields where waste solids from the dairy have been land applied. As noted previously, 91% of the solids generated at the facility are exported for land application onto third-party fields. The remaining solids (9%) are applied to fields at Sage Dairy on a three-year rotational basis (e.g., the 9% going onto one third of the the fields one year, applied to a separate third of the fields the following year, etc). According to both Terry Sr. and James Jones, the solids are plowed into the soil shortly after application. Once surfaced irrigation is applied to the northernmost fields (Fields 1, 2, and 3; Figure 7), There is a potential for the surface irrigation return flow from these fields to transport pollutants to Sandy Hollow Drainage.

Photo was taken overlooking Field #1. Surface irrigation flows down and across the field into the Sandy Hollow Drainage. Once in the Drainage, return flows are transported to the irrigation return ditch. From the ditch, water flows on to the south in the continuation of the Drainage (see Figure 6).
